RANGE HOODS / UNDER-CABINET

BABY-PRO I

24231-S • (30" - 390 CFM - Stainless steel)

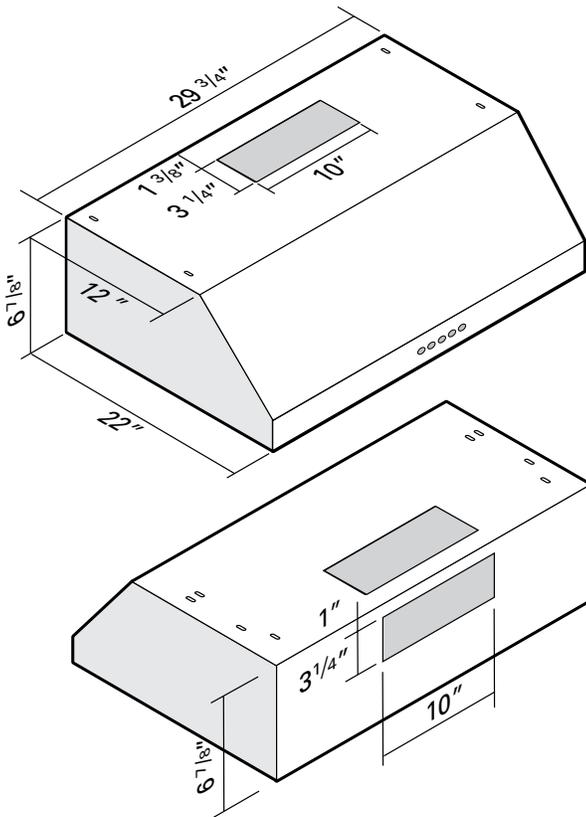
DIMENSIONS

- 390 CFM
- Noise level: low speed 0.7 to hi 9.0 sones (high speed)
- 3-speed controls
- 2 LED bulbs, GU10 (incl.)
- 5-layer aluminum filters (incl.)
- Rear or top vent (rectangular)
